# Manhole Inspection Summary

Manhole # S15CC1017MH

Insp Date: **2/1/07 2:25 PM**

**Location** Address: **3837 COTTAGE AVE**

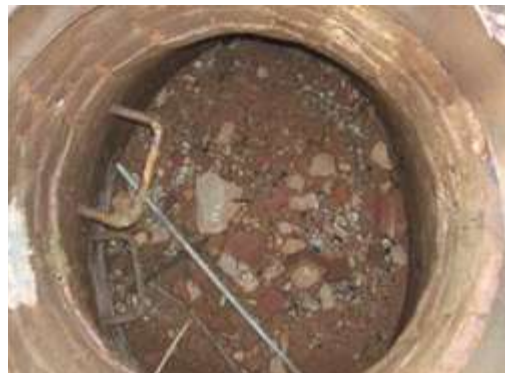
Top View

Corroded steps. Channel debris.

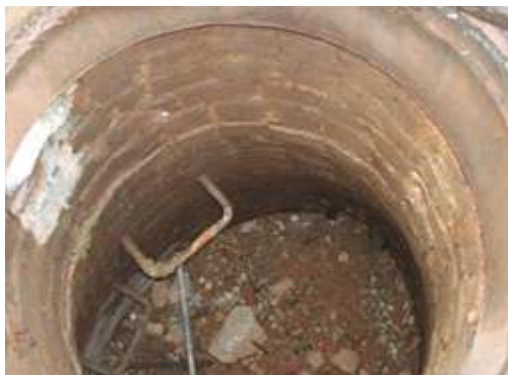
Defect

Frame leaks. Adjustment deterioration, loose brick and infiltration. Corbel infiltration - other side.

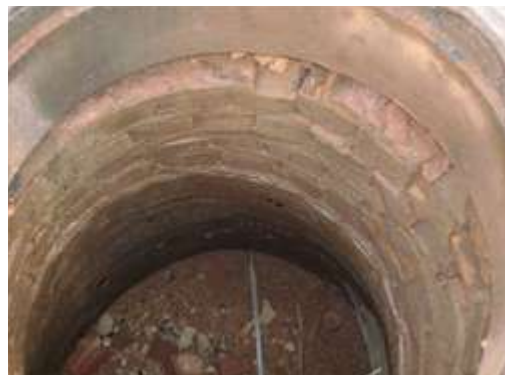
Defect

Frame leaks. Adjustment deterioration, loose brick and infiltration. Corbel infiltration.

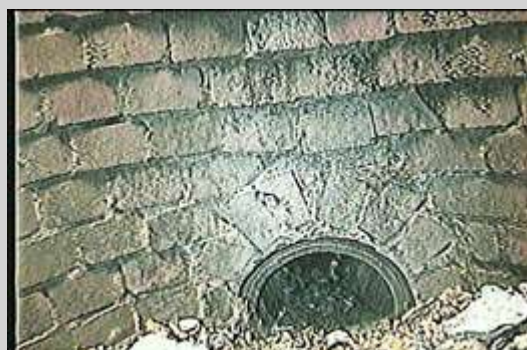
Pipe Out @ 12 O'Clock

Barrel deterioration and infiltration.
